Dysart Tolbooth and Town Hall

Conservation Management Plan

V. 6a November 2008

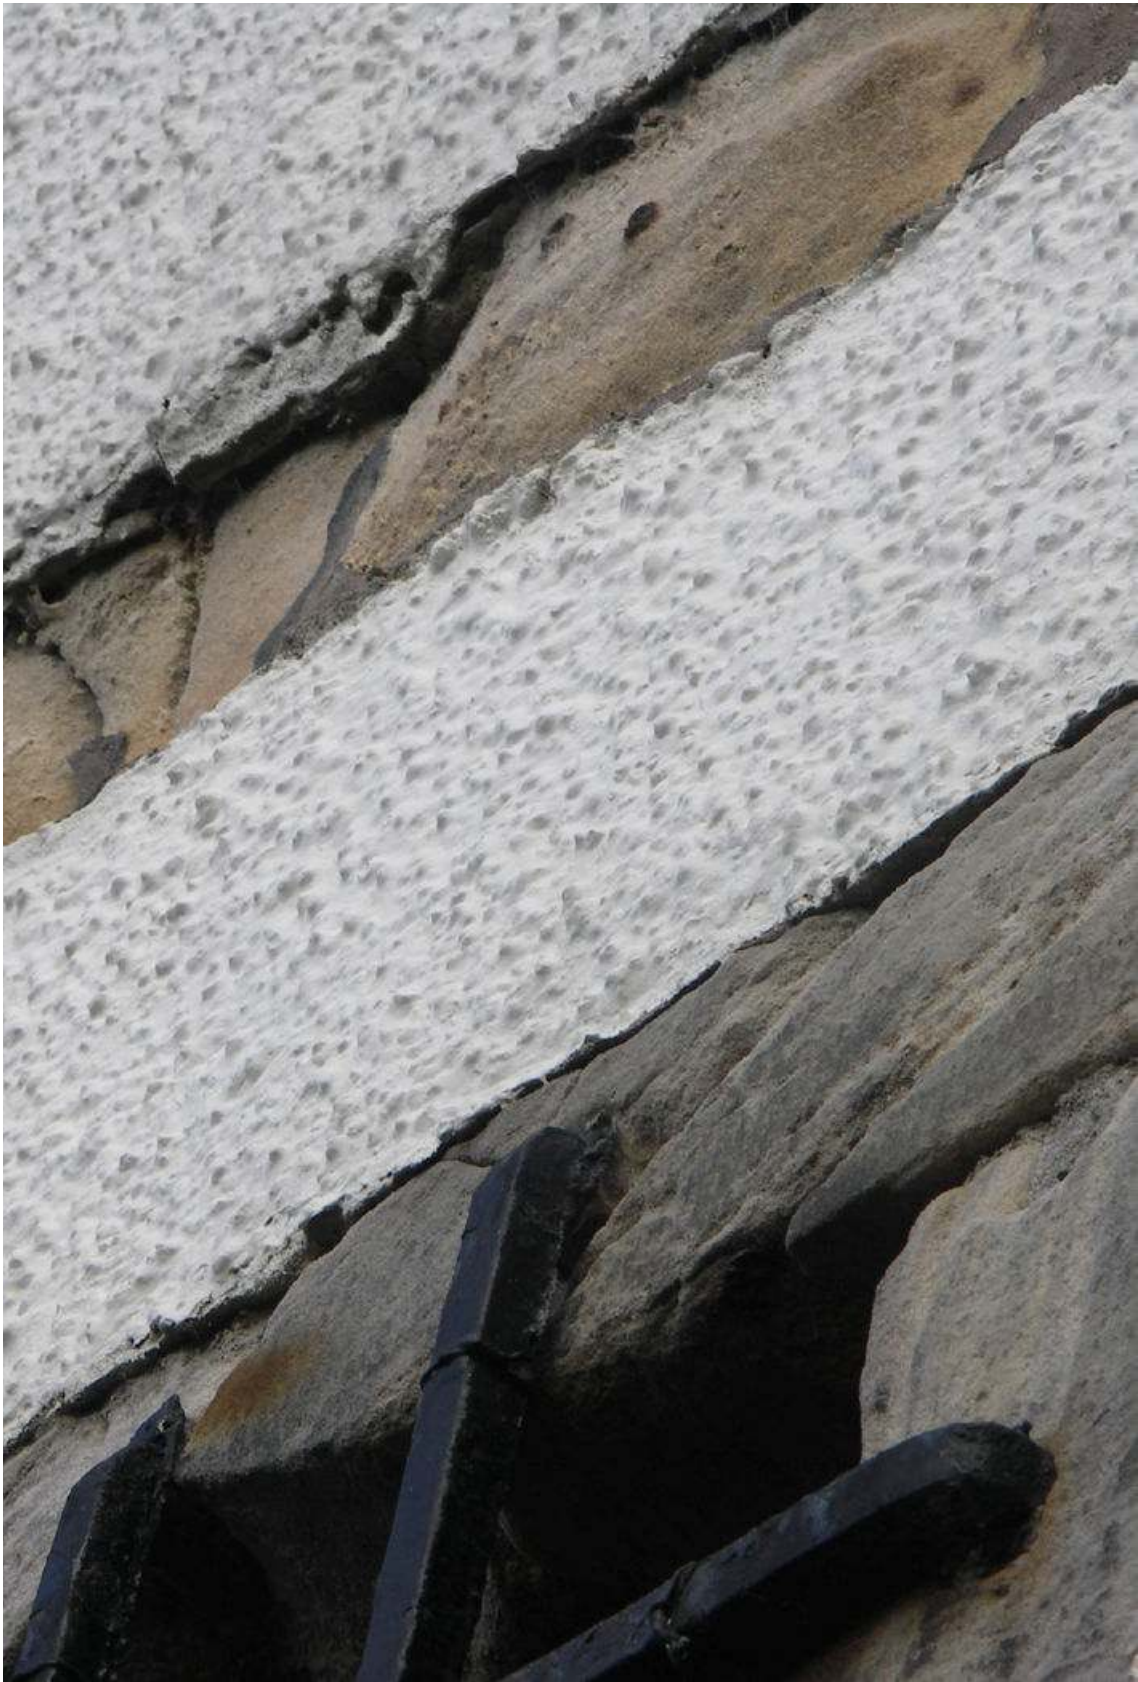
Fig 33: Detail of masonry decay accelerated by cement render.

- Use of cementitious materials during maintenance in the 20th century has resulted in damage to the Tolbooth. The application of cement pointing to the dressed stone and cement render to the rubble has resulted in raised damp levels in the building and accelerated decay of the relatively soft sandstone of which the Tolbooth is constructed. This has resulted in loss of some carved stonework. Internally, the application of a cement slurry to the plasterwork has accelerated its decay.

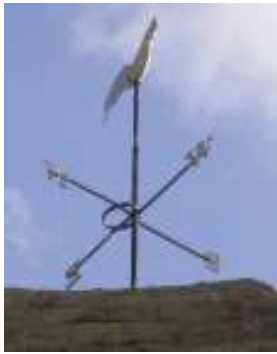
EXISTING CONDITION	PROPOSED REPAIRS
1.	Weathervane

In working condition although hoop is dislodged.	Requires re-gilded and minor repairs. Consider lightning protection.

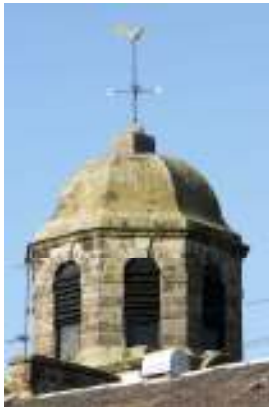
2.	Stone octagonal ogee roof

In reasonable condition although some weathering visible, particularly of pointing. Pointing type not visible from the ground. Possibly originally lead clad. No cladding currently visible. Further investigation required	Some repointing required. Estimate 20%. Possible recladding in lead.

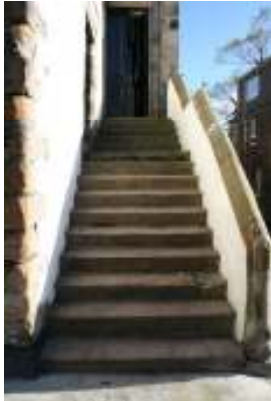
5.	Clock	Working clock in good condition.	Repaint metalwork. Renew lighting.
6.	External Stairs

The external stairs originally served only the Tollbooth, but were later extended when the Town hall was rebuilt, and they now serve both entrances. The external stairs are constructed from natural local sandstone and are in reasonable condition. They have been cement pointed. The top stone in the balustrade capping has been replaced with a cement capping. See also 'west elevation'	Remove cement pointing and replace with lime pointing. Remove cement balustrade capping and replace with stone to match adjacent. Nom 1.5m length. Replace cement render with lime harl, and carry out repairs of masonry wall as required. Allow 20%.

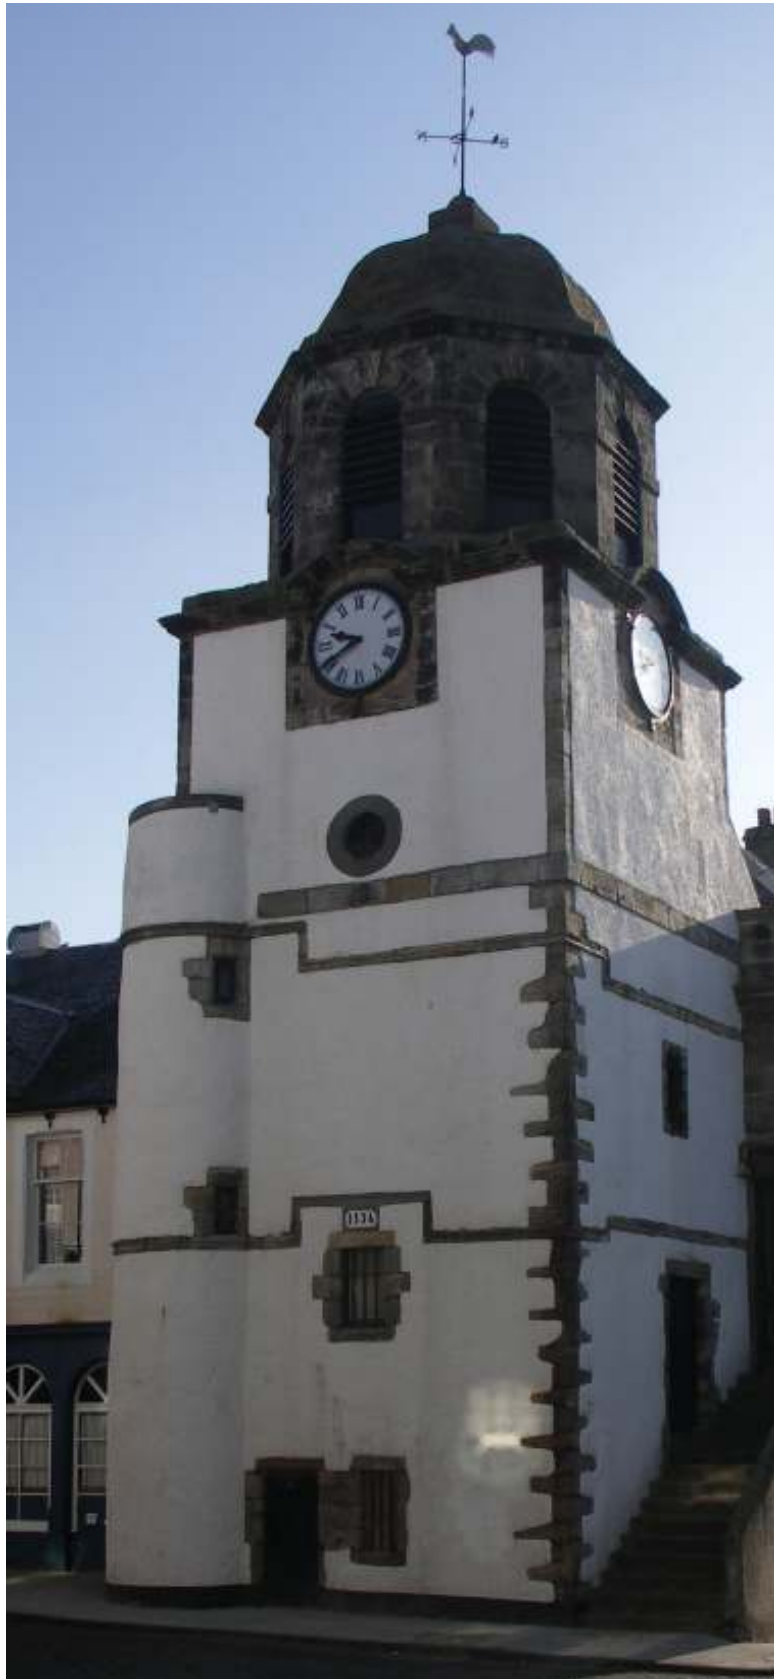
Fig 34: North Elevation

8.	North Elevation		
8.01	Pointing	Existing exposed pointing is cement and has damaged some stone work as a result	Remove cement pointing 100% and replace with lime pointing to suit on entire elevation.

8.02	Harl	Existing cement harl is causing stone degradation around edges. Condition behind the harl is unknown although internal dampness suggests it is contributing to water damage in the walls.	Remove all cement harl, and cement pointing behind. Replace with lime pointing and lime harl, with limewash finish. Allow for 10% stone repairs behind harl once it is removed.

8.03	Exposed stone on elevations	All exposed sandstone is being damaged due to cement pointing. However, with exception of that noted below, is in reasonable condition	Minor repairs to exposed stonework - 5%

8.04	Upper string course	Cement pointing as noted above. Otherwise in reasonable condition	Pointing - as 8.02
8.05	Middle string course	Cement pointing as noted above. Some cement patches replacing previously damaged stonework.	Pointing - as 8.02. Remove stone patches, indent with sandstone. Nom. 1m length.

8.06	Lower string course	Cement pointing as noted above. Some cement patches replacing previously damaged stonework.	Pointing - as above. Remove stone patches, indent with sandstone. Nom. 2m length.

8.07	Window 1 (circular)	All circular stonework surround has been cement coated.	Remove cement coating and repair stone. Assume 100% moulded indents.
8.08	Window 2 (top window on stair tower)	Timber frame is rotten in some areas, the glass is cracked and is painted black internally	Repair and repaint timber frame, replace glass with crown glass.

8.09	Window 3 (middle window on stair tower)	Timber frame has rotten in some areas.	Repair and repaint timber frame.
8.10	Window 4 (bottom window on stair tower)	Timber frame is rotten in some areas, is painted	Repair and repaint timber frame, replace glass with

tower)	black externally and the glass is cracked.	crown glass.
8.11	Window 5 (window beneath date stone)	This window is an inappropriate modern timber framed window with wired glass. The stone cill is spalled. Cast iron bars to window are in reasonable condition and are painted black.	Remove window and replace with appropriate timber framed window. Indent required to cill nom. 500mm length. Minor repairs to bars and repaint.

The 1576 date stone has had cement edge repairs on all 4 sides.	Full stone repair and repaint.

8.15	Stair tower	Stair tower head capping is stone edges, with cement infills and patches.	Remove cement and repair stonework. Nom 1.5m length.
8.16	Other notes	It can be seen that the walls above and below the lower string course are not in line, with the 1 st floor about 25mm further out than the ground floor. While this looks like historical movement it may be connected to the cracks internally at ground floor and further investigation should be undertaken.	Structural Engineer to inspect all cracks in the building, and carry out analysis using tell tales to ascertain whether movement is historical or ongoing.

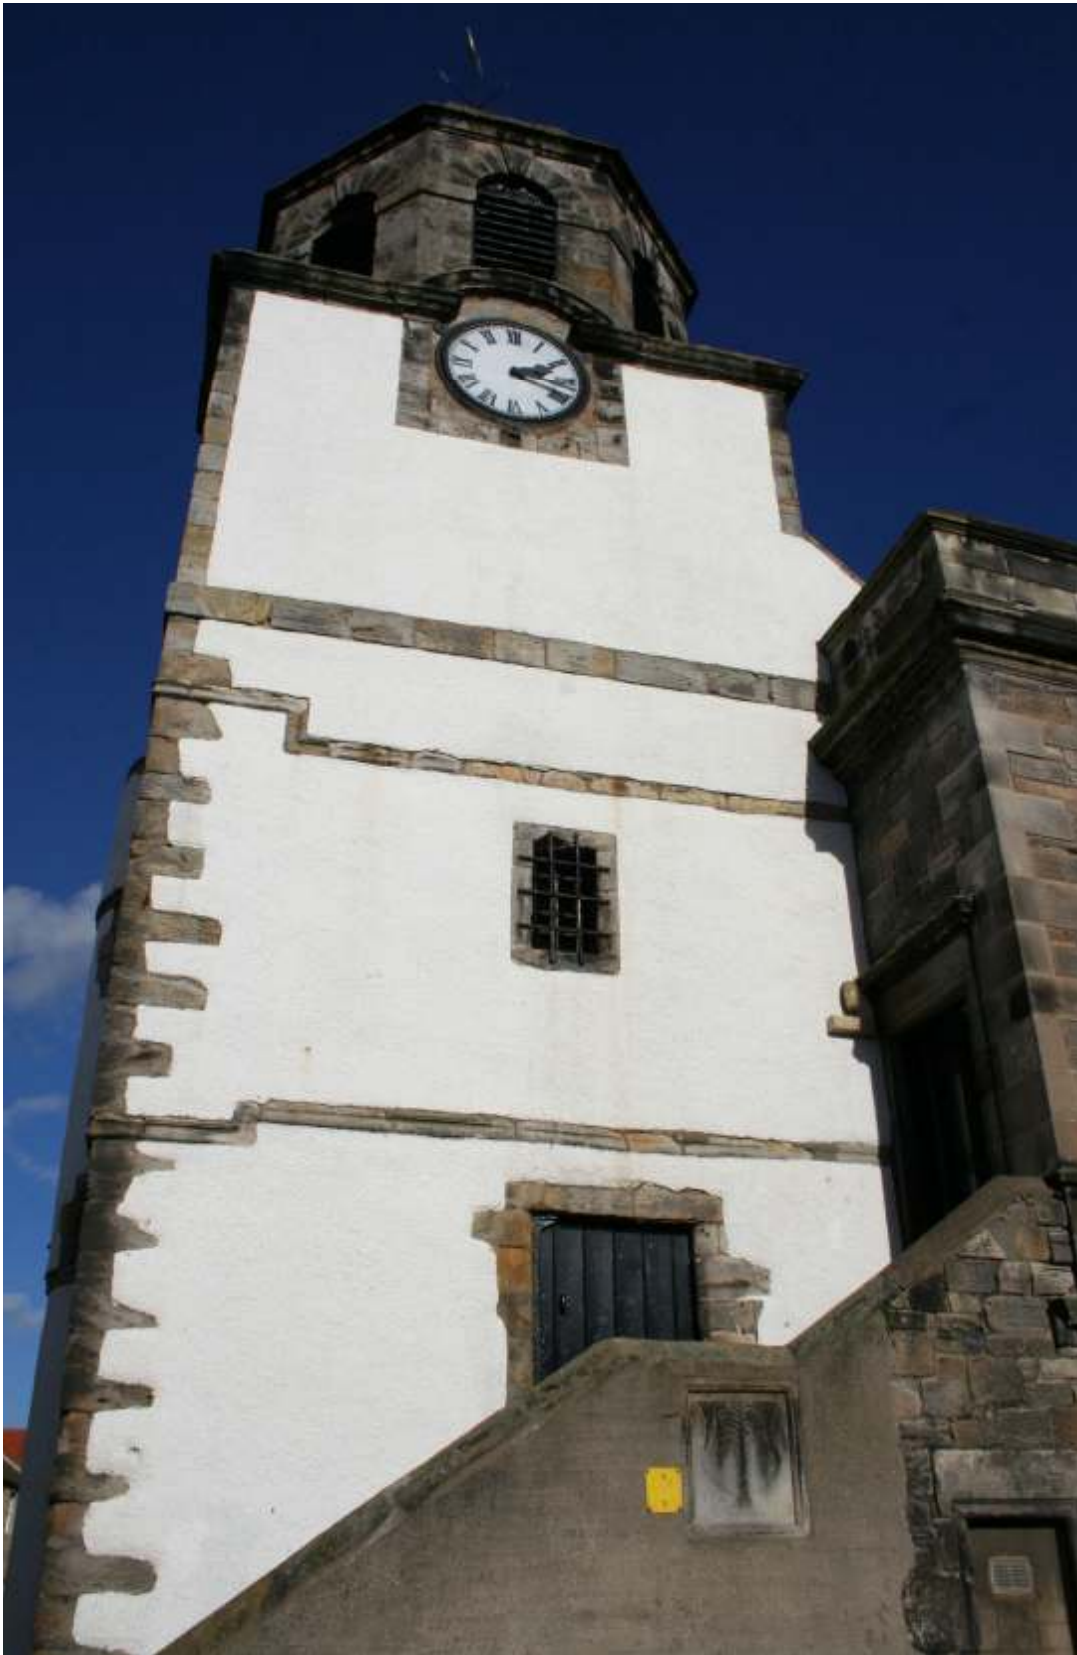
Fig 35: West Elevation

9.	West Elevation		
9.01	Pointing	Existing exposed pointing is cement and has damaged some stone work as a result	Remove cement pointing 100% and replace with lime pointing to suit on entire elevation.

9.04	Upper string course	Cement pointing as noted above. Otherwise in reasonable condition	Pointing - as above.
9.05	Middle string course	Cement pointing as noted above. Some cement patches replacing previously damaged stonework and exposed stonework in poor condition.	Pointing - as above. Remove stone patches, indent with sandstone. Nom. 3m length.

9.07	Window 7	No window in the opening. The window is covered with 2 layers of bars in reasonable condition. However the stone	Repair stones locally to avoid removing the iron grills. Consolidate with lime rather than stone indent if possible.

Existing door is modern redwood with original iron strap hinges. The lintol is split in 2 places, and has partially come away internally and is therefore not acting structurally. The quoins are badly decayed and cracked with some cement patches. The door has been repaired in the past with a cast iron bar under the lintol and frame on the north side of the door. This cast iron post is rusting and is cracked.	Repaint and minor repairs to door. Replace lintol fully with new stone, remove cast iron bar and post, indent stonework. Nom. Size 300 x 600mm.

9.10	External Stair Elevation	19 th Century (?) construction with medieval (?) decorative panel inset into façade. 75% of the wall has cement covering, with the remaining as exposed stone. There is a roll margined, blocked up window, and this has been infilled faced with cement. There is evidence in historical photographs of another panel below.	Remove cement on the whole wall, lime point, lime harl and lime wash finish. Allow for 20% stone repairs. Approximate area of wall is 25m ² on street side, and 10m ² on stair side. Evidence of the lower panel is to be investigated once the cement render is removed.

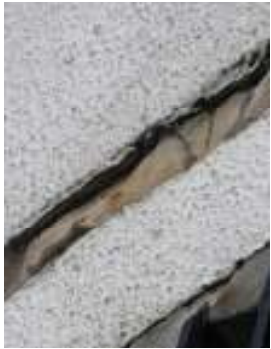
9.06	Lower string course

Cement pointing as noted above. Some cement patches replacing previously damaged stonework.	Pointing - as above. Remove stone patches, indent with sandstone. Nom. 0.5m length.

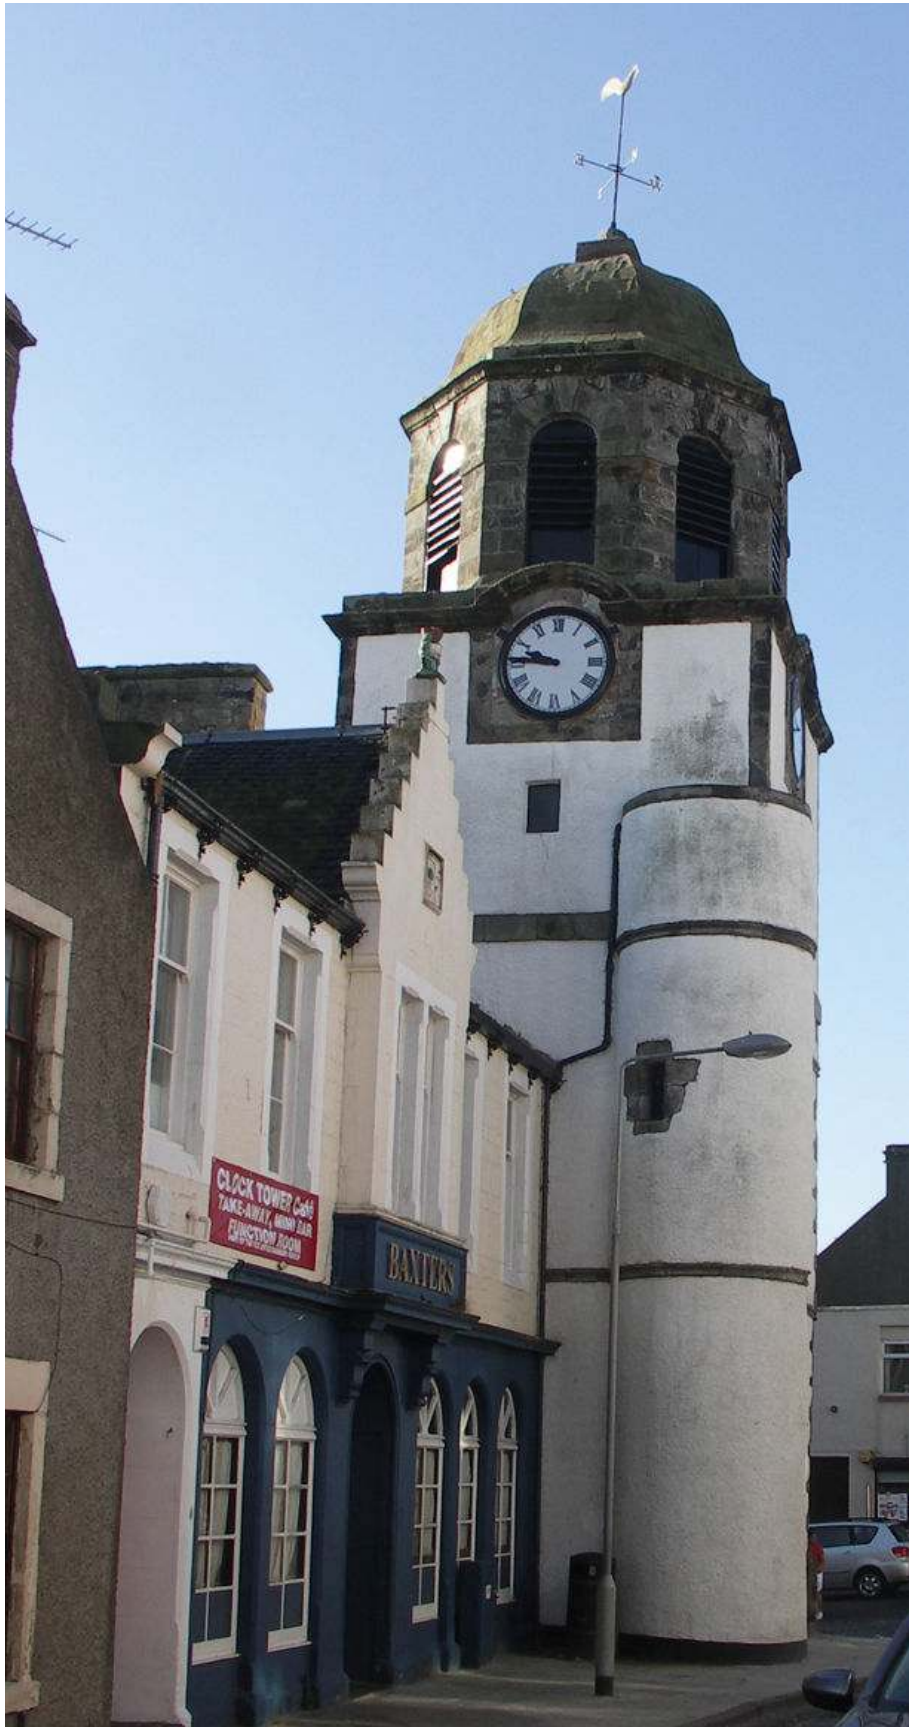
Fig 36: East Elevation

10	East Elevation		
10.01	Pointing	Existing exposed pointing is cement and has damaged some stone work as a result	Remove cement pointing 100% and replace with lime pointing to suit on entire elevation.

10.03	Exposed stone	All exposed sandstone is being damaged due to cement pointing. However, with exception of that noted below, is in reasonable condition	Minor repairs to exposed stonework - 5%

10.06	Stair tower	As north elevation	
10.07	Chimney stack	Sandstone chimney stack has heavy cement pointing and stone cornice. It is assumed that the stonework is not in good condition due to the extent of pointing. The chimney is capped with slates, some of which are broken. Approx size of chimney stack 3m x	Remove cement pointing, carry out stone repairs nom. 15%, repoint in lime. Cap chimney heads.

2m. Pigeons are roosting in the chimney pots.	
10.08	Cement haunching to gutter.	Cement haunching to neighbouring slate roof likely to crack and leak.	Remove cement detail and install lead secret gutter.
10.09	Drain pipe	Nom. 70mm cast iron rain water pipe in reasonable condition.	Repaint and minor repairs
11.	South Elevation		
	This was not visible from the ground and as such no detailed condition report could be made. However it is assumed some minor repairs will be required.

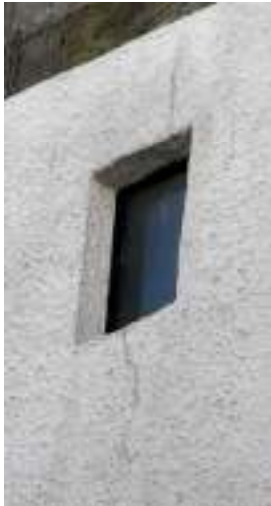
10.02	Harl

Existing cement harl is causing stone degradation around edges. Condition behind the harl is unknown although internal dampness suggests it is contributing to water damage in the walls. There are two cracks in the harl above and below the window below the clock. This may be due to shrinkage of the render but should be further investigated once harl removed.	Remove all cement harl, and cement pointing behind. Replace with lime pointing and lime harl, with limewash finish. Allow for 10% stone repairs behind harl once it is removed.

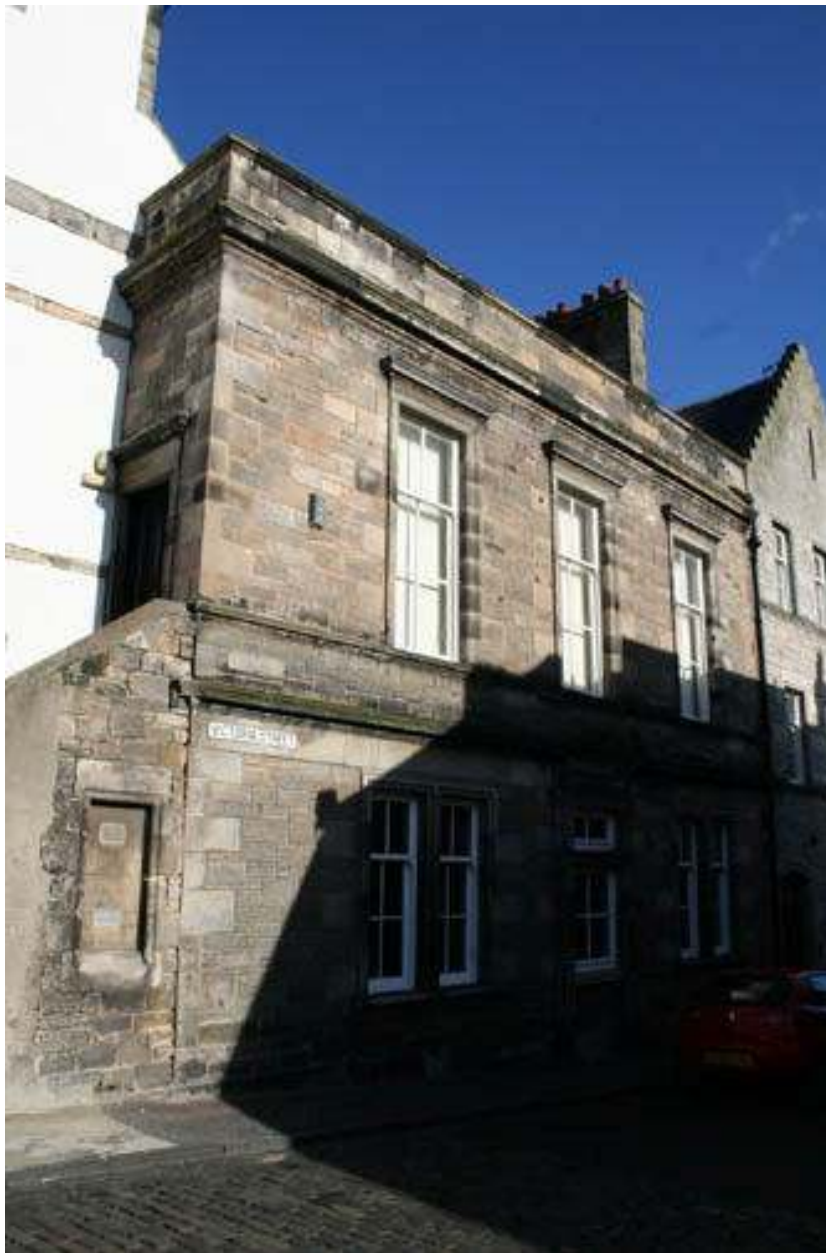
Fig 37: Town Hall West Elevation

12.0	West Elevation of Town Hall		
12.01	Stonework	Generally in reasonable condition	Minor repairs where required. Allow for 2%
12.02	Pointing	Existing pointing is cement, and is much corroded above architrave, with vegetation growing in joints	Remove cement pointing 100% and vegetation, and replace with lime pointing to suit on entire elevation.
