EARTH MORTARS RESEARCH PROJECT

Stage 1: Knowledge Review & Research Strategy

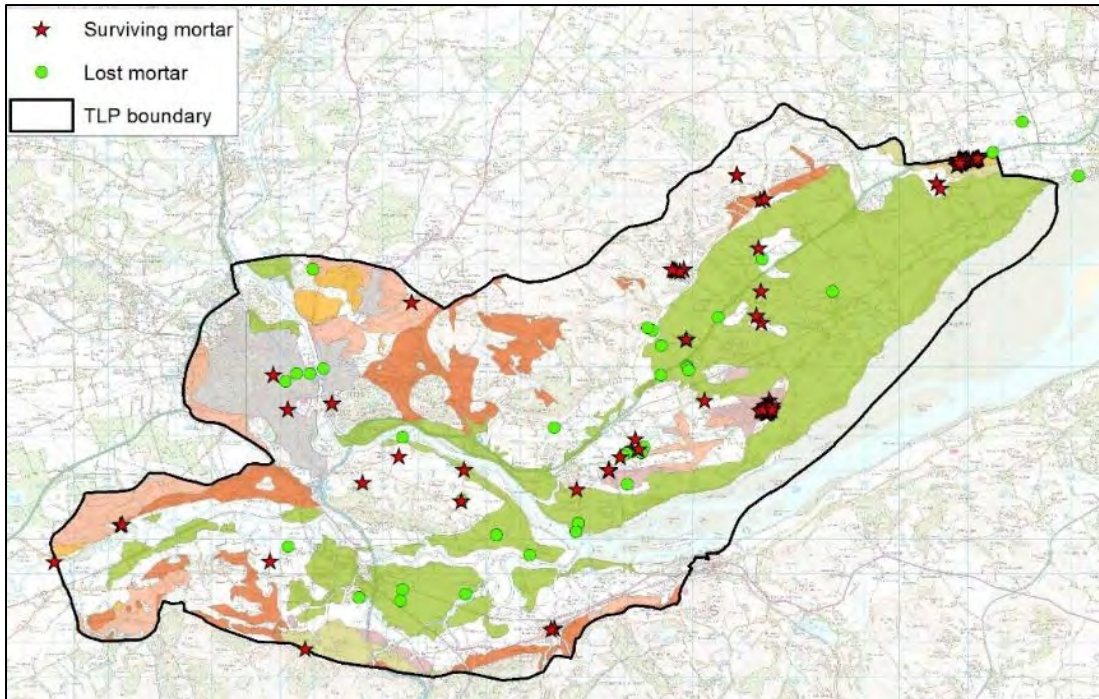
Fig. 4: Map of earth mortared structures in the Tay Landscape Partnership area.

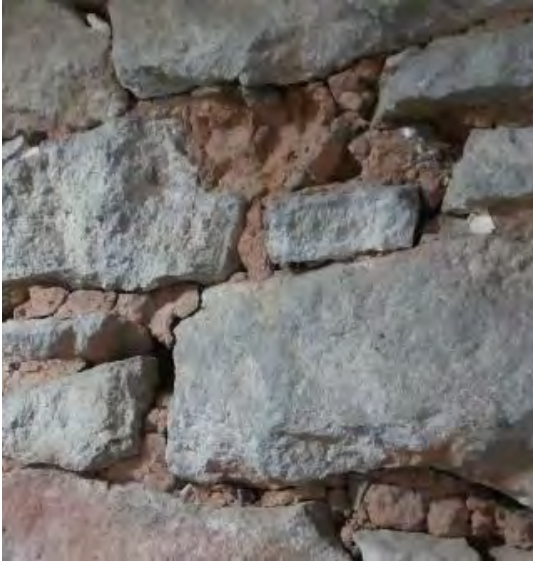
Fig. 5: Example of earth mortar, used as dug, from very close to site, Main St. Longforgan, early 19th C. Shrinkage cracks as a result of high clay content in chimney wall.

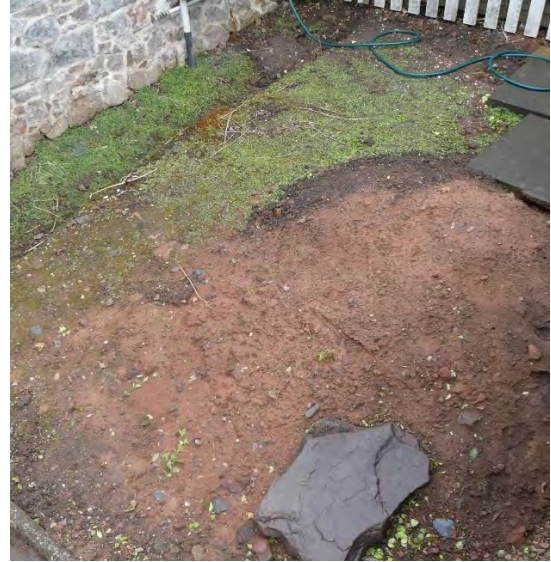
Fig. 6: Stirling series soil, in rear garden of house, note external lime pointing.

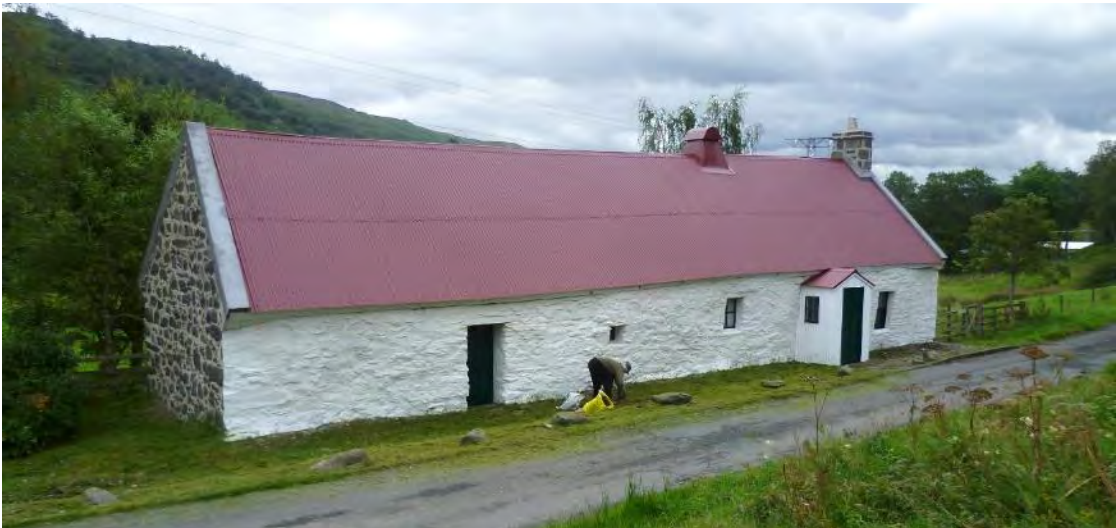
Fig. 7: Moirlanich Longhouse, weak earth mortared rubble with lime pointing & wash. The leaning section to the right of the porch is shown in repair below.

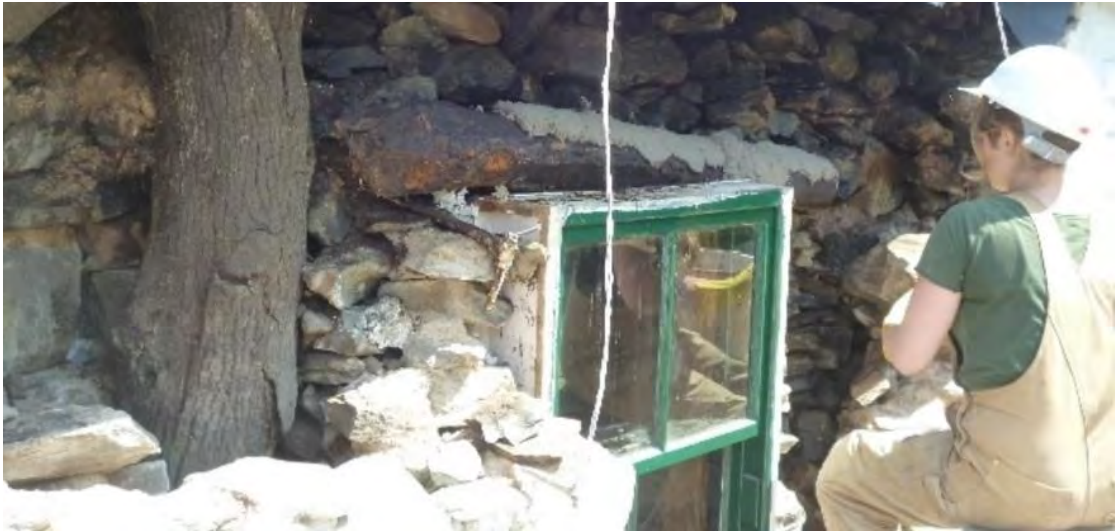
Fig. 8: Back face of inner leaf exposed during repairs at Moirlanich, with cruck leg having benefitted from the preserving effect of earth mortar drawing away moisture.

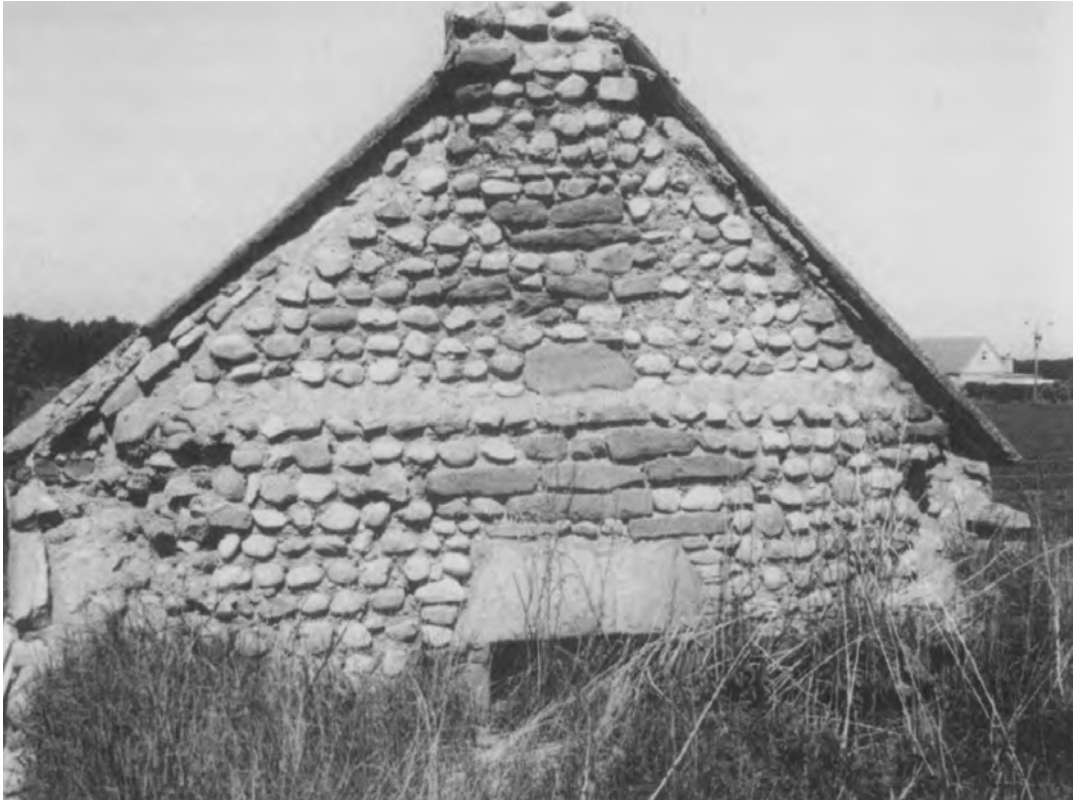
Fig. 9: Clay and Bool wall, Cowfurach, Moray. © HES. Similar arrangements of round river stones laid in herring-bone rows can be found in other countries.

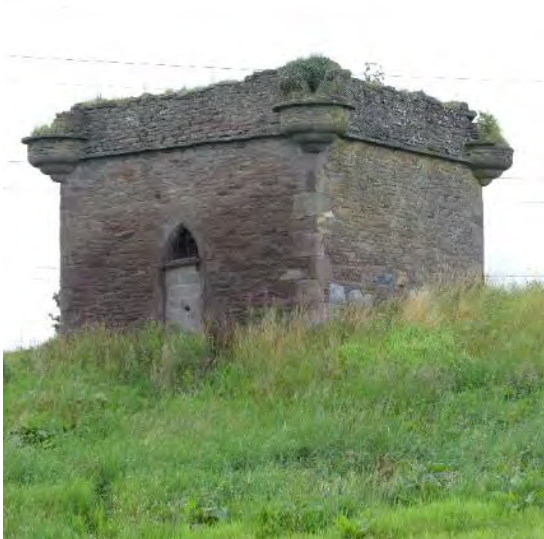
Fig. 10: Castle Huntly Doocot.

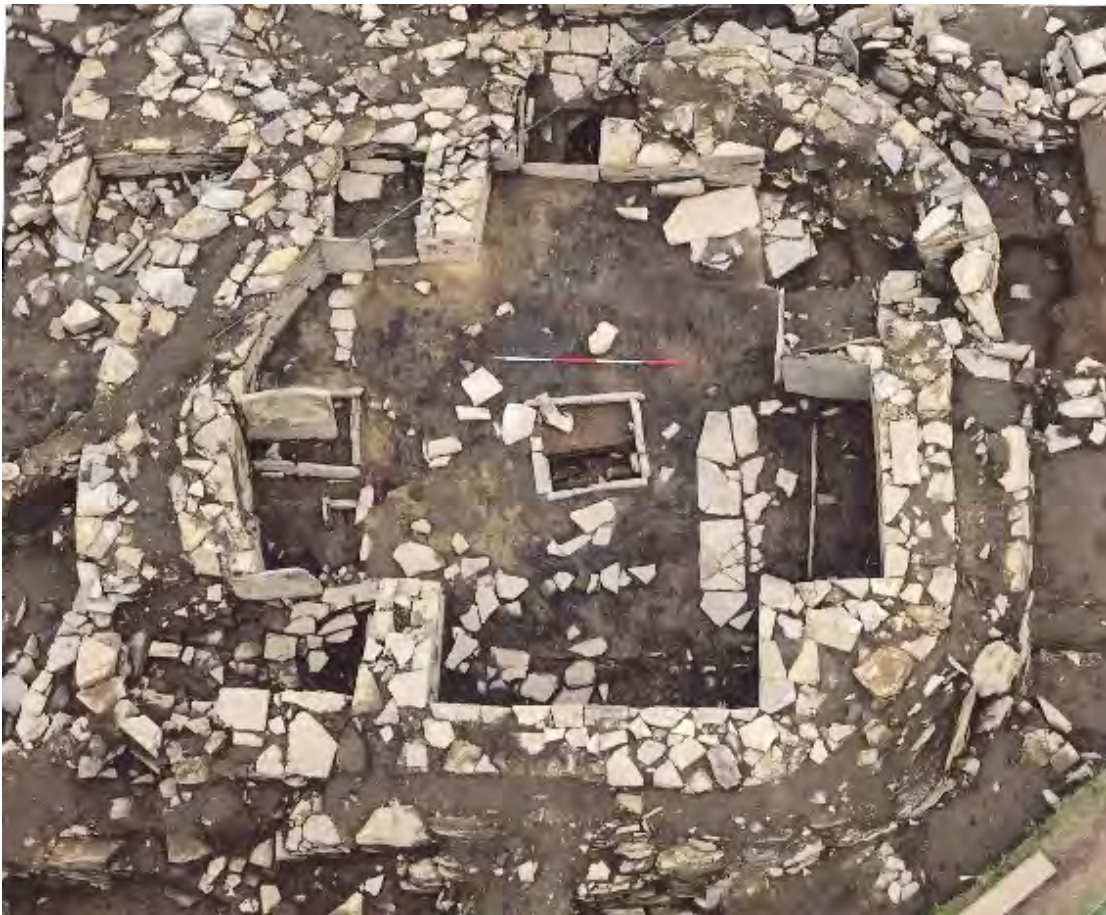
Fig. 12: Part of the emerging Knap of Brodgar complex, with clay floor and mortared masonry walls. © Hugo Anderson-Whymark.

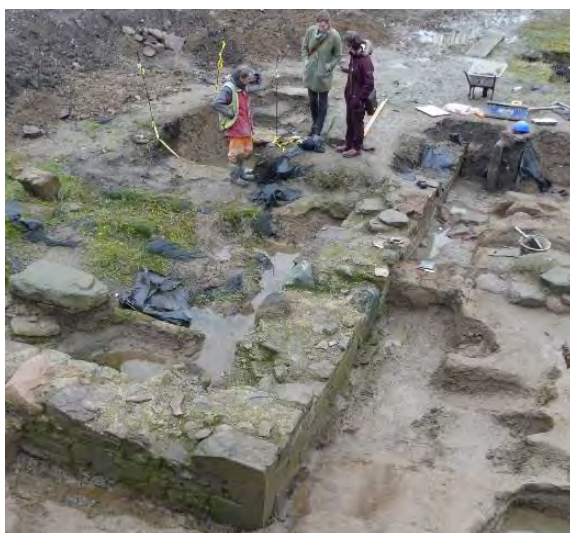
Fig. 15: Carmelite Friary, Perth, earth mortared wall bases, may have had lime mortared masonry above.

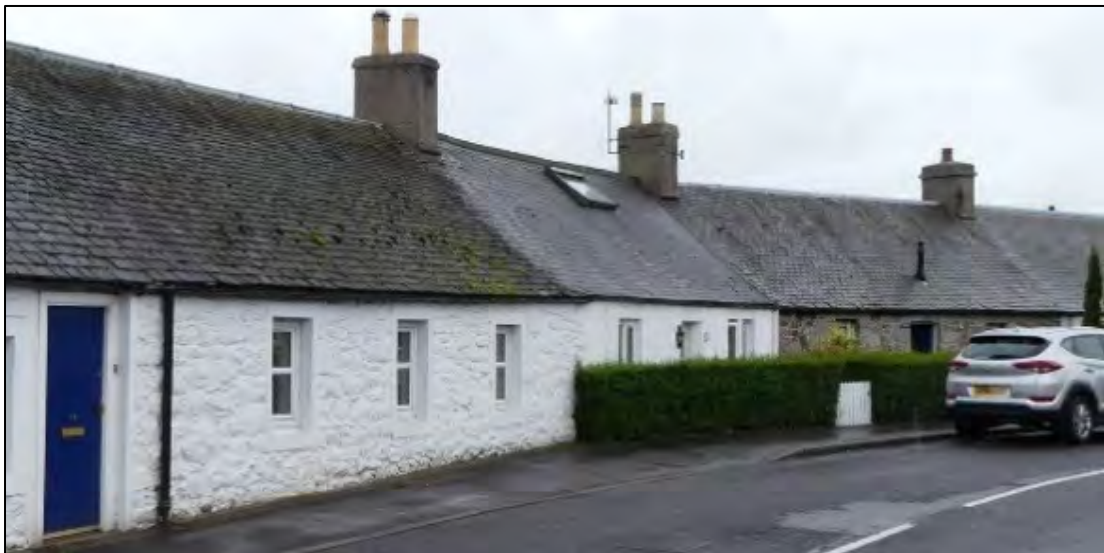
Fig. 15: The village of Longforgan was ‘built with turf and stone or clay for mortar, and not a vestige of lime’ before 1777 (OSA). Soon after, all were replaced by the landowner with smarter buildings, built of earth mortared masonry pointed in lime. See Figs 5 & 6.

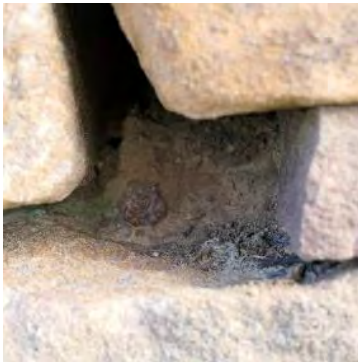
Fig. 18: Earth mortar, severe external decay.

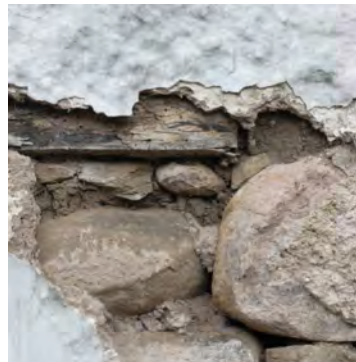
Fig. 19: Earth mortar concealed behind lime finishes.

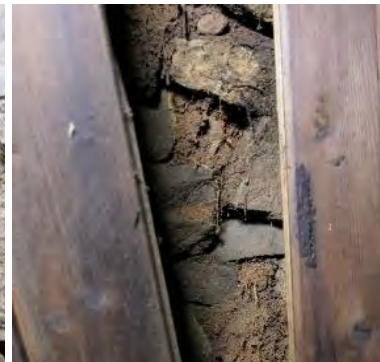
Fig. 20: Earth mortar concealed behind internal linings.

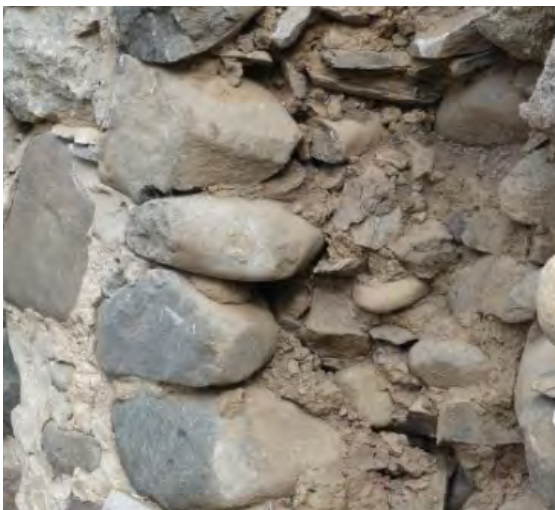
Fig. 21: Earth-mortared wall with lime pointing, the face having fallen away due to water ingress at the wallhead and lack of restraining through stones tying the outer to the inner face.

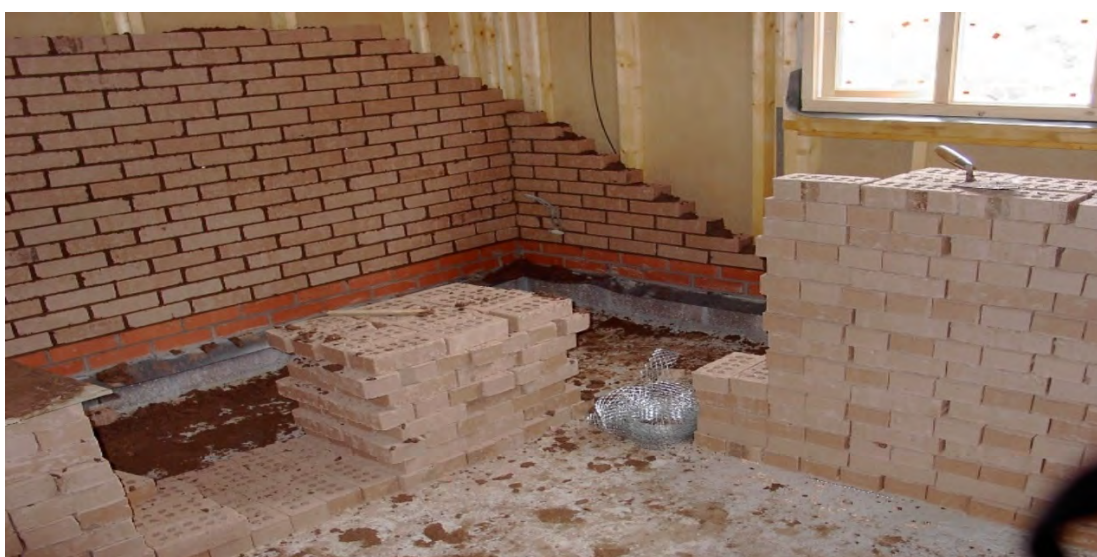
Fig. 22: Earth mortar in contemporary eco-house, Perthshire.

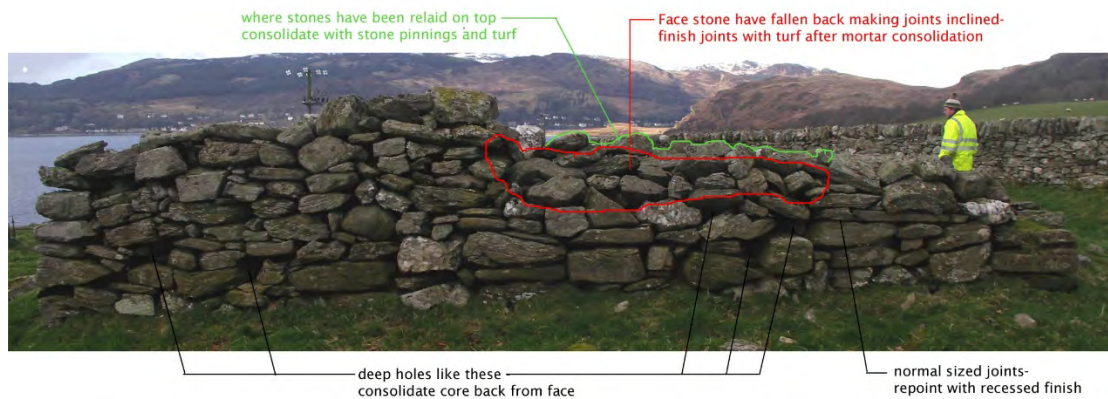
Fig. 21: 9th C. Kilmichel Chapel, Bute, prior to repairs.

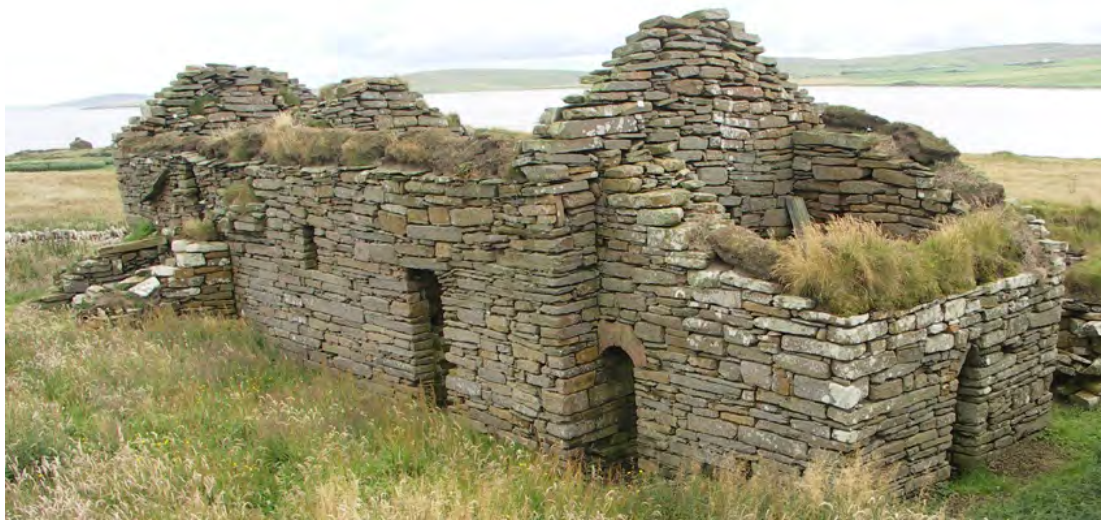
Fig. 23: Eynhallow Monastery, Orkney, movement of masonry followed erosion of earth mortar.
