CONSERVATION REPORT

THE MELVILLE TOMB, COLLESSIE

Abridged Version

February 2003

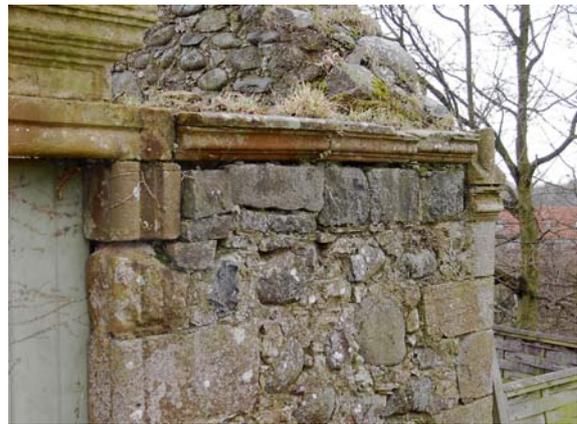
4.2.3 **West Wallhead.** The head of the west wall has been raised by approximately 240mm. The door lintol was reset on two dressed sandstone quoins, with a moulding similar but not identical to, the moulding on the original quoins, indicating that these were re-used from some other building. Either side, the dressed sandstone capstones were raised onto a new stone of roughly square basalt rubble. The skew put stones were not altered with the result that they no longer align with the cap stones.

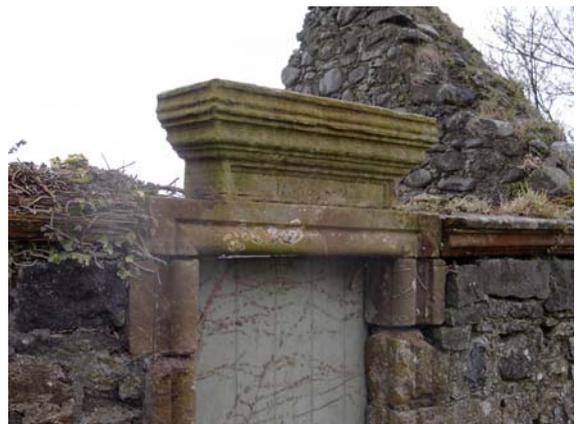
4.2.4 **Pediment Stones.** On the west wall, above the door, stands a corniced sandstone panel, with the inscription 'Rep'd 1831'. There is a similar stone on the east wall, over the central armorial panel. This stone has no inscription and is raised up on two small rectangular basalt blocks, the rest of the elevation being dressed sandstone. Both these stones have roughly hewn backs and are much more weathered than the others in their vicinity.

- a) Pediment Panels. The two pediment panels will be removed and set aside. After the repairs are completed these will be laid inside the Tomb, where they will be accessible, but protected from the elements.
- b) West Wall Eaves Course. The raised eaves course will be reinstated at its original level, in alignment with the skew putts. This will involve the removal of the 19th C. basalt rubble course and the two door quoins.
- c) Window Infill. The rubble infill to the south gable window will be removed.
- d) Door. The inappropriately designed 19th c. door will be removed, though the ironmongery will be retained for possible re-use.
- e) Possible Soil Infill. A small test hole will be excavated to determine whether the original floor was at a lower level. If this is the case the infill soil will be removed and the original floor conserved as appropriate.

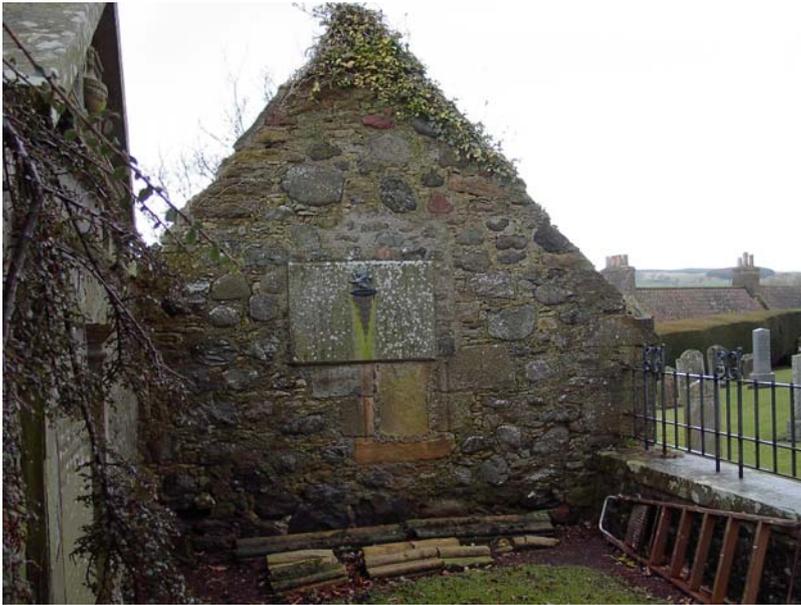
- 4.3.1 North Gable. The north gable is of rubble construction, which is in reasonably good condition on both sides, though minor local repairs are required. The wall head is exposed, with the original moulded skew stones having been removed, some of which are lying at the foot of the wall. Some of these are broken or have suffered other damage. The unprotected wallhead allows ingress of water and this has encouraged vigorous growth of ivy and other vegetation, growing from inside the Tomb. The ground level has been raised, meaning that the wall is partly retaining, leading to damp also at low level. The original window had sandstone roll moulded quoins and has a flush infill of basalt rubble in lime mortar. On top of this, a funerary plaque has been inserted, dated 1935, damaging the lintol and some quoins.

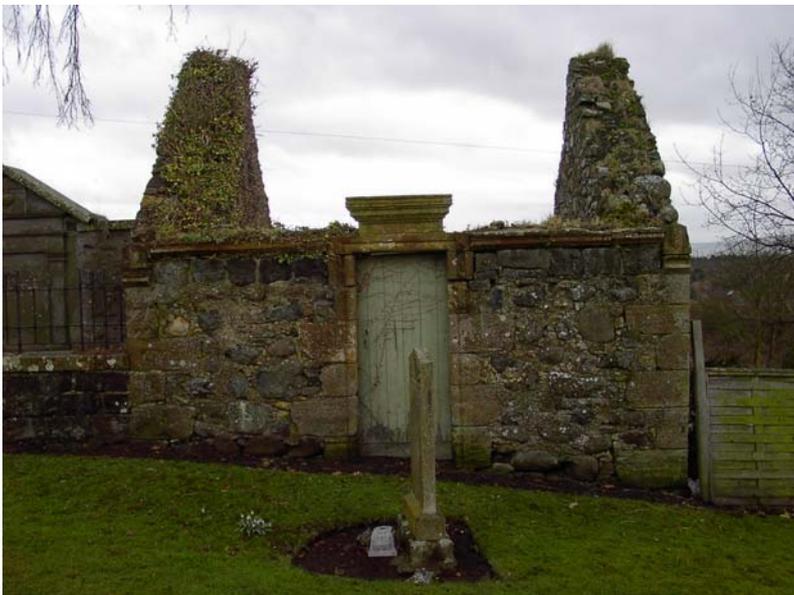
- 4.3.2 West Wall. The west entrance wall is of rubble construction with sandstone dressings. The raised wall head is exposed, allowing ingress of moisture and supporting vegetation growth. The moulded sandstone eaves course stones are suffering locally severe delamination due to moisture ingress and vegetation growth. The rubble is in reasonable condition on both faces, though the original flush face has been lost. The door is a modified boarded and ledged pine door, painted green and with 2 iron

strap hinges and a timber boxed mortice lock. The timber work is in poor condition, but the ironmongery could be refurbished.

- c) Door. A new oak boarded door will be fitted to the existing iron pivots. The existing door ironmongery will be re-used where possible. The year date will be inscribed in a discrete location. The door will allow gentle ventilation of the interior. This will

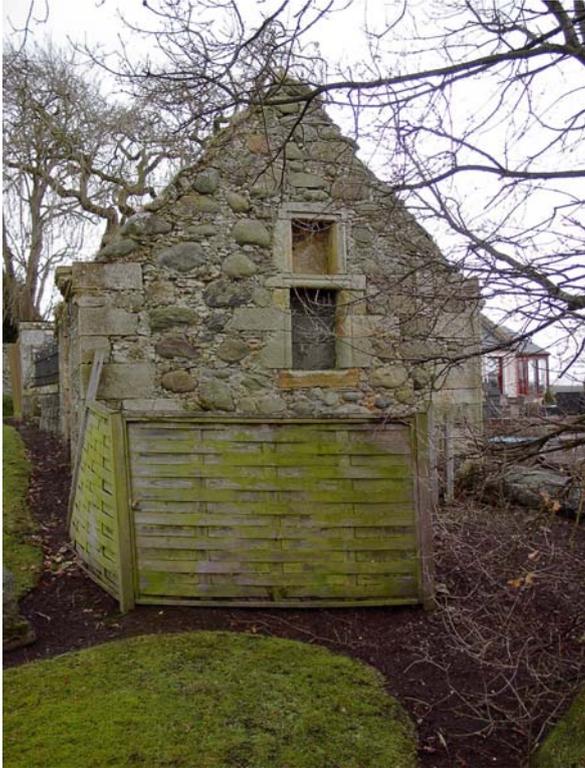
4.3.3 South Gable. The south wall is of rubble construction with sandstone dressings. The rubble work is in reasonable condition, though there is one rodent hole at ground level and the original flush face has been lost. The wall head is exposed, with the original moulded skew stones having been removed, one of which is lying inside the Tomb. The unprotected wallhead allows ingress of water and this has encouraged growth of vegetation. The window opening has sandstone roll moulded quoins and has a recessed infill of basalt rubble in lime mortar. On top of this there is a sandstone dressed niche, presumably for an armorial panel, which has been lost. A timber enclosure fence to the compost heap has been nailed to the joints in the sandstone quoins.

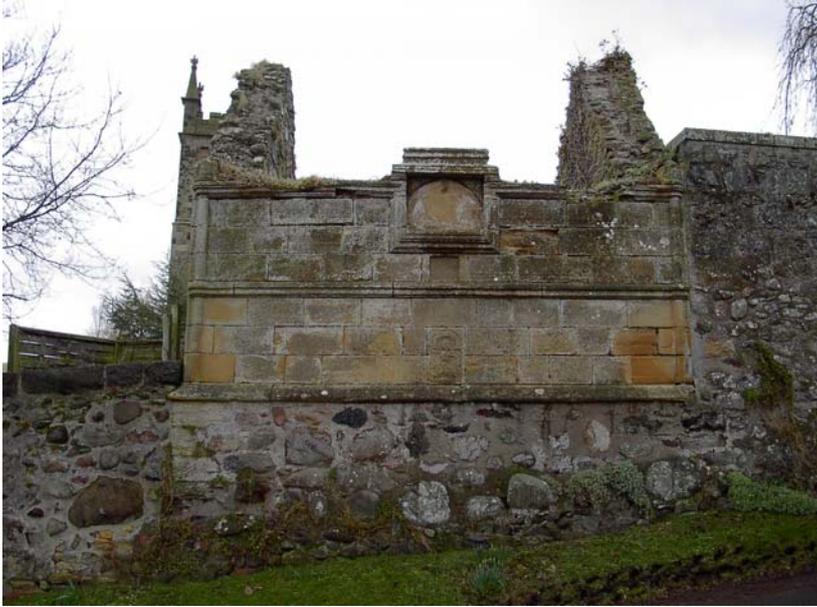
4.3.4 East Wall. The east wall comprises a dressed sandstone wall built on the gently battered retaining rubble Kirkyard enclosure wall. This wall is B listed. The wall has been raised to the north to a level higher than the Tomb eaves. The rubble, though generally sound, has received a crude cement pointing, which is failing. The wall of the Tomb is divided into two horizontal panels of ashlar. The lower panel is of fine lime mortar jointed ashlar, undecorated apart from a central memento mori sculpture of a skeletal figure surmounted by an inscribed arch. The panel sits on a large bellcast moulded plinth course over the rubble. This moulded course has some impact damage to its north end.

The upper panel, of similar ashlar, sits on a moulded string course and has an extensive Scots text incised in the upper three courses. It has a central recess for an armorial panel, though only traces remain of a heraldic shield and more complex side mouldings. The panel is surmounted by a moulded pediment panel. This panel is considerably more worn than the other masonry and is mounted on two basalt blocks, both indicating that it is not part of the original design. Below the armorial panel there is a small undecorated square recess. The wall is framed by clasped, half round pilasters which run into the skew putt mouldings. The wall is capped by a moulded eaves course, which matches that on the west wall.

This wall has benefited from facing away from the prevailing winds. Much of the text is still sharp, though there is locally severe loss on certain stones due to delamination and the effects of algae and lichen. Mortar joints are generally open. There is some loss of face from spalling due to moisture movement from the retained ground on the north side of the lower panel. The wall head is thoroughly colonised by ivy and other vegetation, with deterioration of the stone mouldings, primarily delamination, quite advanced. One stone is completely missing. The steady deterioration of this important and vulnerable wall is evidenced by the accumulation of small sandstone debris at its base.

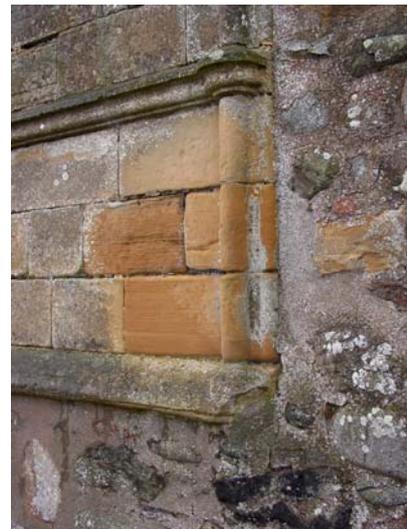
- a) Damp Movement. The lack of a roof over the earth floor, the raised ground in the Rossie burial enclosure and the cement pointing to the adjacent rubble all contribute to the movement of moisture through the masonry, particularly the ashlar faced east wall. This mechanism brings salts to the surface of the stone, causing spalling. The salts also push iron staining to the surface of the stone.

This decay is most evident in the right side of the lower panel, where there is most retained ground and adjacent cement pointing.

To address this decay mechanism, the retained ground should be removed or drainage improved, where possible. The cement pointing should be removed and replaced with a lime mortar pointing.

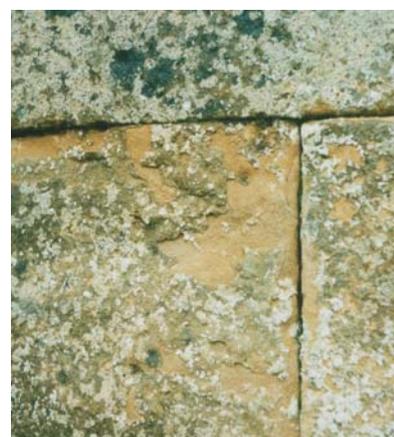
- b) Lichen Growth. The high moisture levels in the walls, caused by the damp movement described above, as well as the exposed wallheads and open joints, creates an environment for organic growth. The growth of lichen on the surface of the stones is particularly apparent on the east ashlar wall. The lichen holds acidic moisture in the surface of the stone, causing decay of the face. It also obscures the lettered text.

The moist environment which encourages lichen growth will be reduced by removing the retained ground moisture pressure, removing the cement pointing, filling open joints with lime pointing and stopping rainwater penetrating the wallhead.

The existing lichen will be lightly sprayed with an approved biocide and left to die off. The dead lichen will then be removed with a dental steam machine, carefully worked over each surface and controlled to as not to over clean the stone.

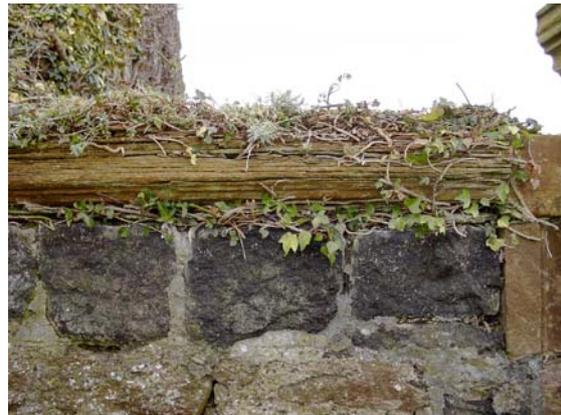
- c) Delamination. The high moisture levels in the walls has led to the leaching out of some of the clay content of the stone, weakening the bond between the minerals. This has exposed the natural bed of the stones, particularly the moulded eaves stones. Once established, this delamination has allowed organic growth to penetrate the natural beds and break the cohesion of the stone.

The existing vegetation will be lightly sprayed with an approved biocide and left to die off. The dead vegetation will then be removed carefully by hand. Stones will be repaired with lime mortar, where possible, or replaced with new stones, dressed to match, where the originals have lost all cohesion.

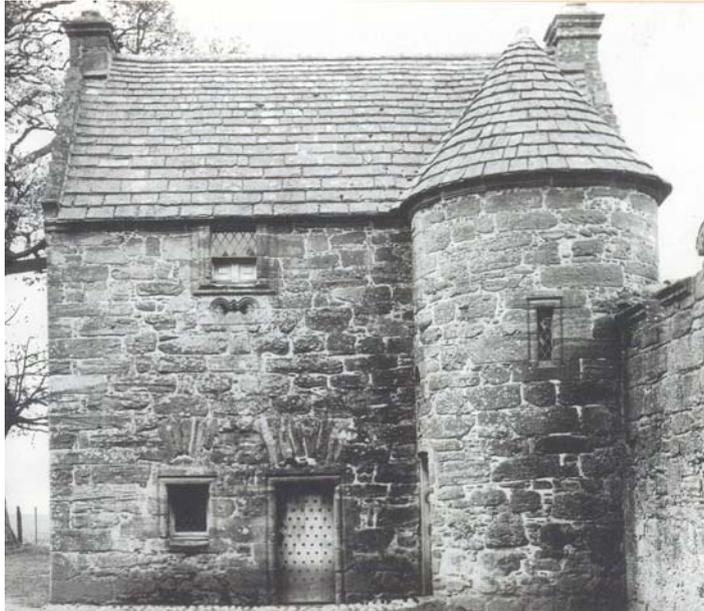
The Summer House at Edzell Castle is dated 1604 and displays a typical stone slated roof, leaded windows and oak boarded door.

- a) Skews. The original skew stones will be reinstated in lime mortar in appropriate positions on the gable wallheads, with new ones cut to match.
- b) Roof. A new roof will be constructed. This will stop moisture penetrating both the interior of the Tomb and wallheads. A timber structure will be fitted to the original sockets in the walls. The roof covering will be stone slates, fitted in diminishing courses with oak pegs to battens. A stone coping will be fitted and lime mortar fillets to the skews. The design will be based on surviving examples of a similar date.
