Dysart Tolbooth and Town Hall

Conservation Management Plan

V. 6a November 2008

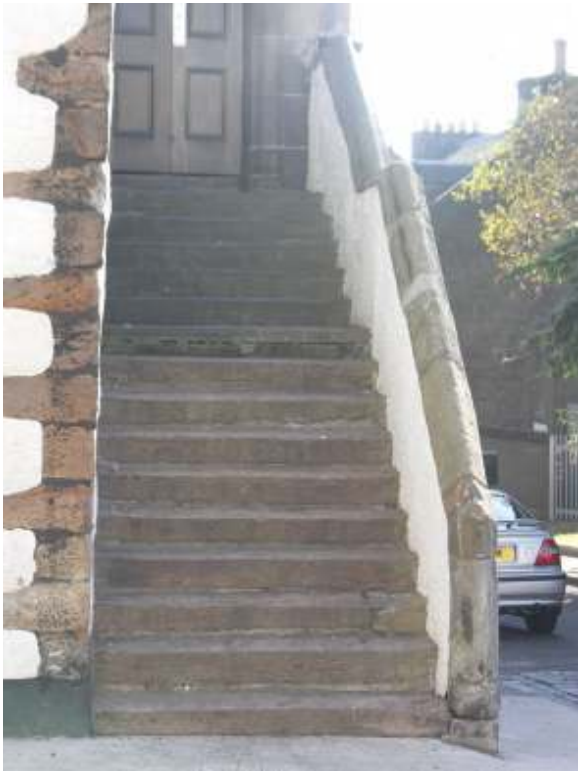
Fig 15: The forestair.

Dysart displays these general features (Fig. 15). Early images suggest that there may have been an external doorway into the void under the stair, though this is blocked by masonry and may have had some other function. It is now covered in cement render and further investigation during the works may be productive.

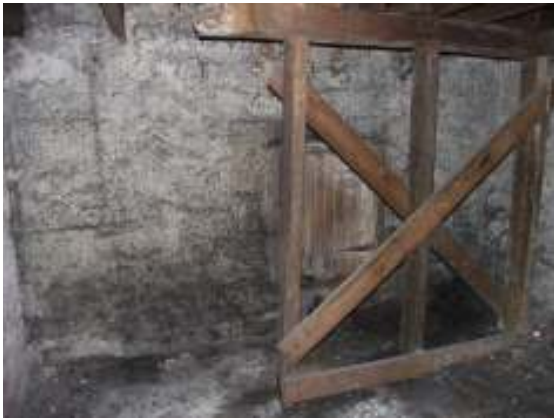
Fig 19: The Ground Floor room.

The ground floor room at Dysart is stone vaulted (Fig. 19). The original door is no longer in place, but the window has both an iron grille and inner timber shutter. While it remains possible the room was a store, this suggests it was used as a cell, with the iron grille for security and timber shutter to prohibit conversations with prisoners. The blocking southern wall may conceal other original features.

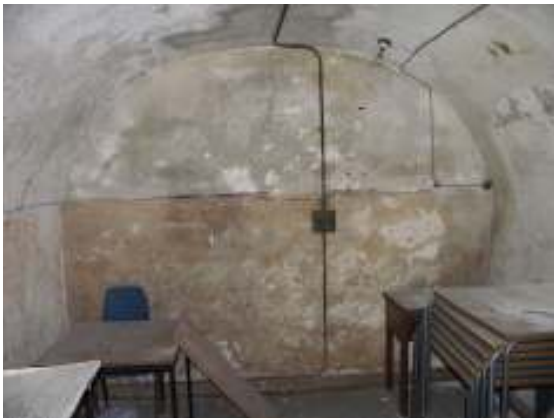
Fig 20: The First Floor room.

The first floor room at Dysart was clearly the highest status room, with good plasterwork (Fig. 20). 19th century images show a tall, round-headed window on the north, similar to ones on the now-replaced contiguous hall to the south. It is possible that the tower room acted as a vestibule for this larger hall and that a blocked doorway remains behind the plaster. There is little evidence of what the original 16th century arrangement was.

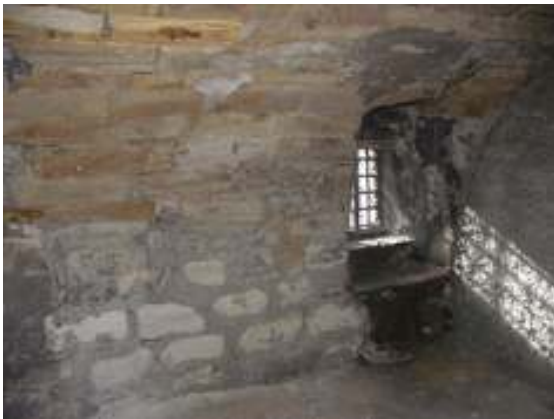
Fig 21: The Second Floor room.

The second floor room is vaulted and plastered (Fig. 21). It has an iron yett and inner timber door to the stair, with the door displaying graffiti. There is a decently sized window to the west, with two layers of iron grilles, but no evidence of glazing or shutters.

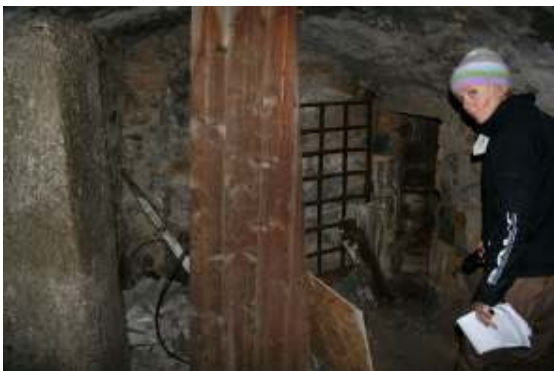
Fig 22: The Third Floor room.

The third floor room is similarly vaulted, with an iron yett remaining, but having lost its timber door, which in this case was on the outside (Fig. 22). It has only one small circular window to the north, again with an iron grille.

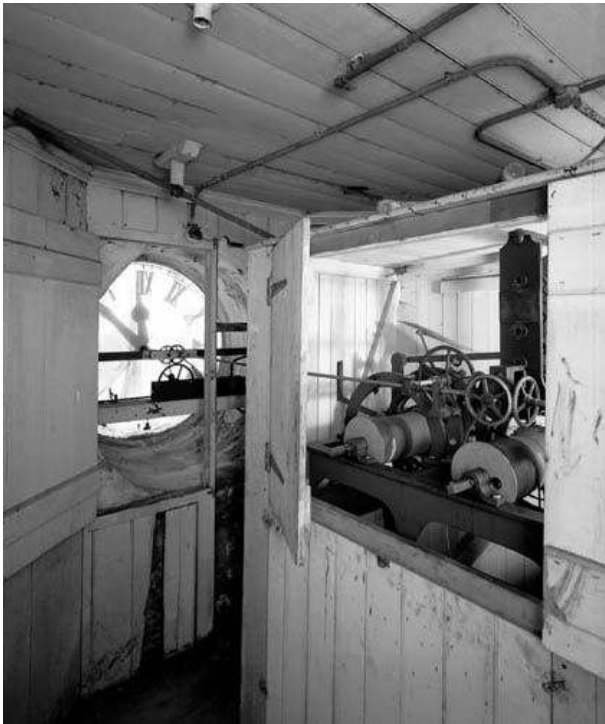
Fig 23: The Clock Stage.

The current mechanism and clock faces were installed in 1876 (Fig. 23). The insertion of a shaft for weights to drive the mechanism, together with a pendulum case, were rather brutally effected and the last significant alteration to the building.

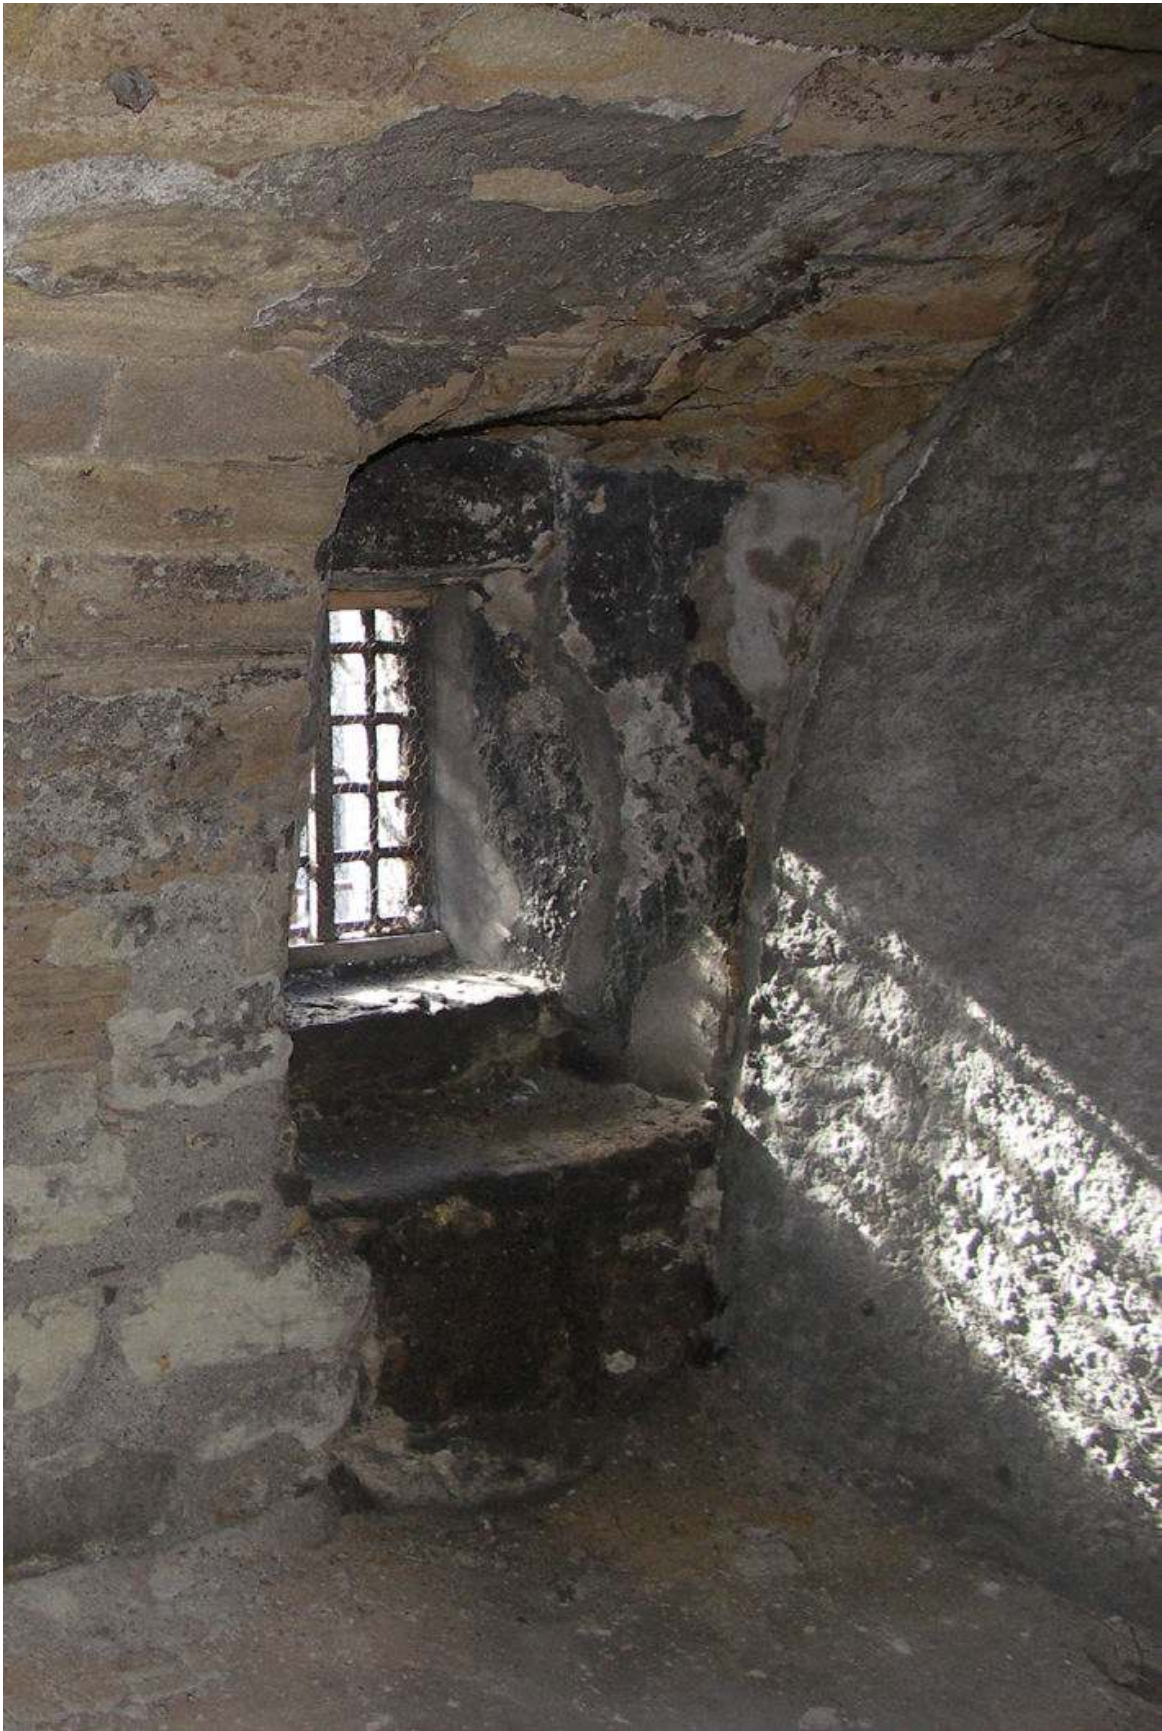
Fig 32: A former double-barred cell window
